# Low-Cost, Semi-Autonomous Pipe Inspection Rover for Guatemalan Hydroelectric Power Plants

Turing Research Laboratory, FISICC, Universidad Galileo, Guatemala

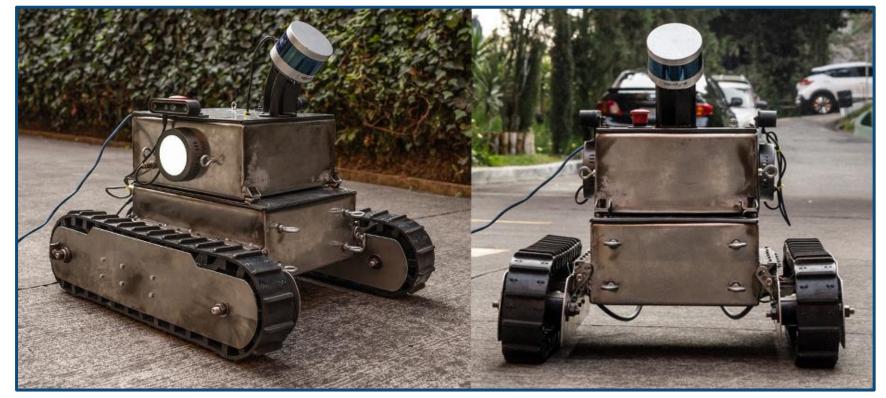
Fig 3. Test distance measurement of a pipe junction and ovality percentage obtained.

The rover shown in Fig. 1 was designed, built, tested and deployed to conduct a successful inspection in the pipes of a hydroelectric power plant in Guatemala. The measurement tool for pipe joint spacing achieved results with less than 95% deviation from ground truth data, demonstrating high accuracy. Additionally, the analysis of LiDAR data yielded the percentage of ovality as illustrated in Fig 3. Finally, proper inclination estimation has been achieved with the 6 DoF IMU sensor, as illustrated in Fig 5.

During the inspection process, the LiDAR sensor continually performs a 360-degree sweep, resulting in the acquisition of 16 concentric rings. These rings are instrumental in spatially reconstructing the circumference of the pipeline. This spatial data is subsequently employed to verify the degree of circularity deviation, or ovality, exhibited by the pipe [2]. Furthermore, the deployment of two lateral depth sensors facilitates the partial reconstruction of specific pipe segments, enabling visual scrutiny to detect any potential imperfection in addition to enabling visual inspection in the GUI deployed in Fig 4. Additionally, precise size measurements are conducted at each pipe joint connecting the diverse segments constituting the pipeline.
